**TECHNICAL AND INVESTIGATIVE SUPPORT FOR HIGH
DENSITY DIGITAL SATELLITE RECORDING SYSTEMS**

Progress Reports #12 - 15

NASA Contract No. NAS5-26493

TECHNICAL AND INVESTIGATIVE SUPPORT FOR
HIGH DENSITY DIGITAL SATELLITE RECORDING SYSTEMS:
MAGNETIC TAPE SURFACE DEFECT ANALYSIS

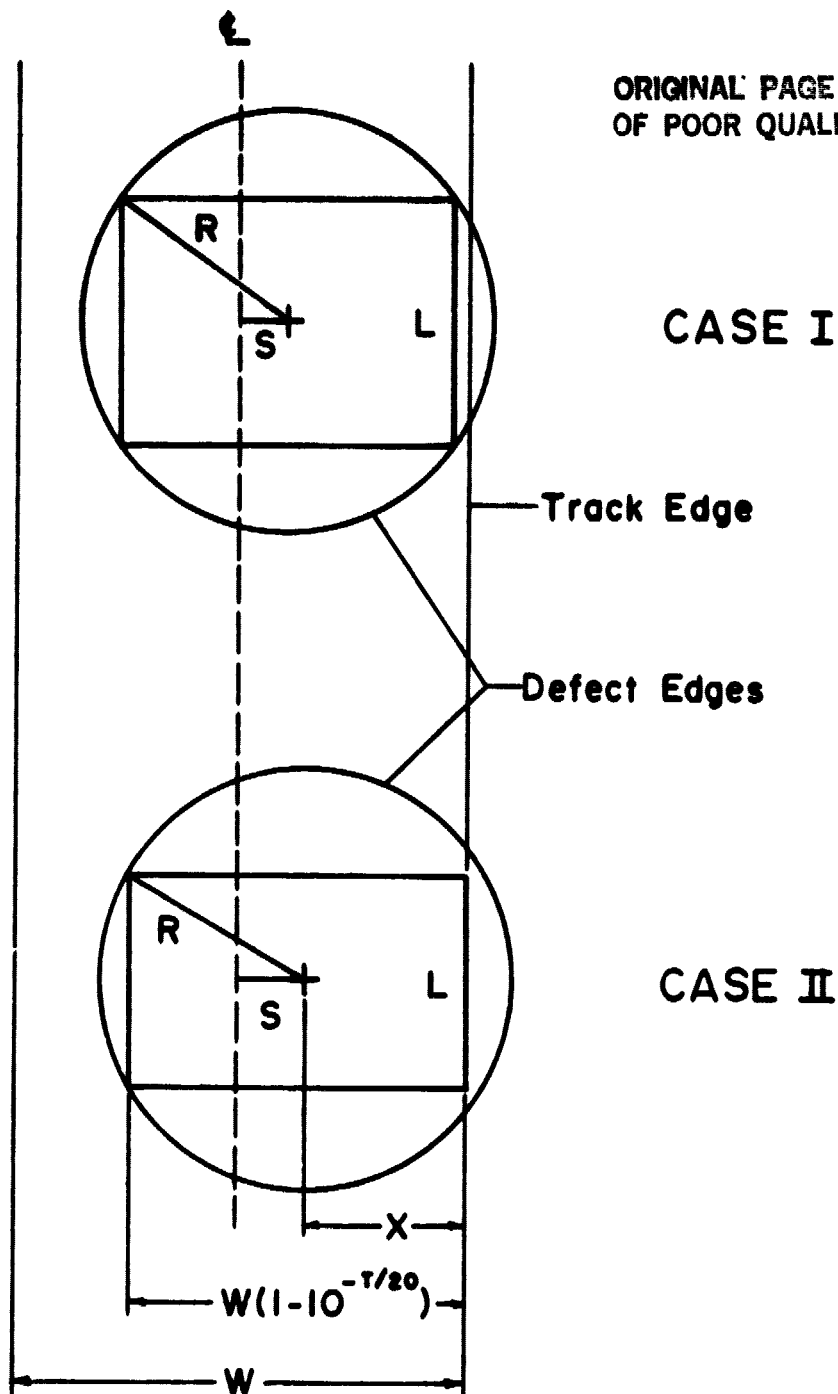
Figure 2.1: Track/defect geometry illustrating dropout length for a dropout threshold $T=12$ dB. In case I, a rectangle of width $3W/4$ inscribed within the circular model defect area determines the dropout length for track center to defect center distance $S < \frac{1}{2}W (10^{-T/20})$. In case II where $S > \frac{1}{2}W (10^{-T/20})$, the width requirement imposed by the threshold places one edge of the dropout rectangle along the track edge, reducing its length. Analytical relationships are specified in the text.

Figure 2.1 illustrates the two general cases of the model defect/track geometry. A 12 dB signal reduction is employed to define the dropout for illustrative clarity, but the model can be extended to any threshold level. The 12 dB level and the circular area assumption imply that the dropout occurs when at least three-fourths of the track width is covered by the defect width. In case I the dropout length L is determined by inscribing a rectangle of width $3W/4$ within the circular defect area where W is the track width. For a general threshold level, the width of this rectangle

In case II, the track center to defect center distance S has been increased so that the rectangle inscribed for case I would no longer fall within the limits of the track edges, but a rectangle of width $W (1-10^{-T/20})$ can still be inscribed between the track edge and the defect edge. Now the Pythagorean relationship becomes:

The two cases are equivalent when $S = \frac{1}{2} W (1-10^{-T/20})$. Case I occurs when $S < \frac{1}{2} W (1-10^{-T/20})$ and case II occurs when $S > \frac{1}{2} W (1-10^{-T/20})$. In the current report $W = 7$ mils and $T = 20$ dB so the transition from case I to case II occurs at a track center to defect center distance greater than 0.35 mils. For large diameter defects, case I can be neglected when the threshold is high (>20 dB). As S increases, the dropout length decreases, slowly at first but with increasing rate until the length becomes zero for $S \geq R - W (\frac{1}{2} - 10^{-T/20}) = R - 2.8$ mils for $W = 7$ mils and $T = 20$ dB.

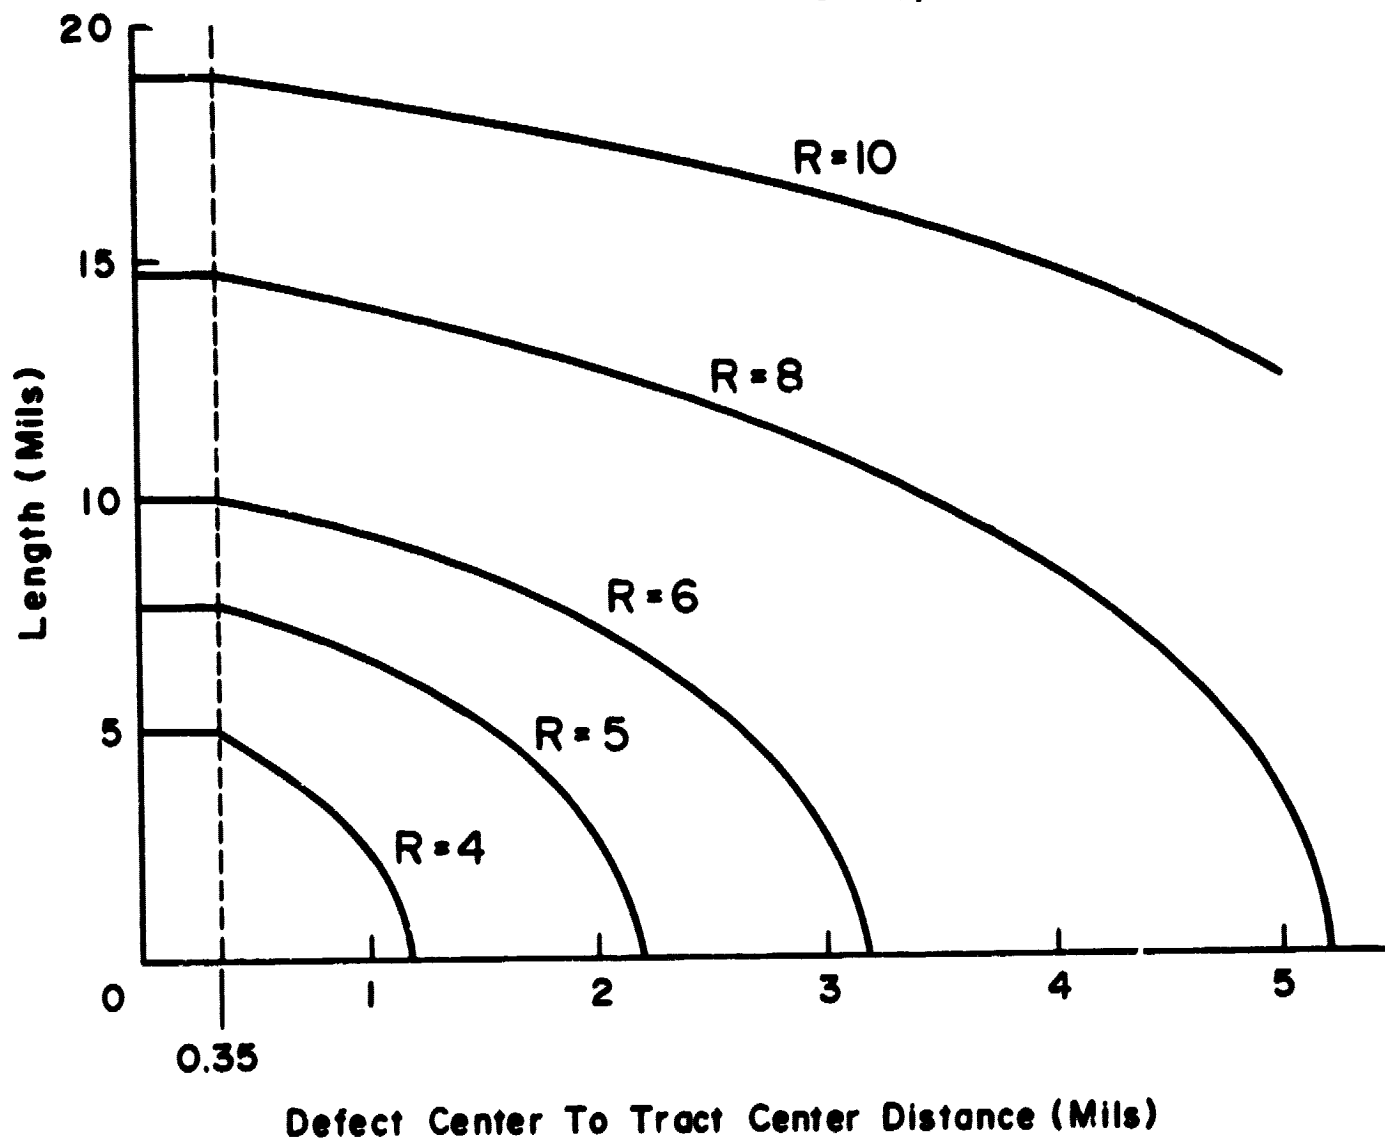
Figure 2.2: Effect of distance between defect center and track center on dropout length calculated for a 7 mil track width and a 20 dB threshold. R is the effective radius of the model dropout. Length is independent of spacing distances less than 0.35 mils. The right edge of each curve is tangent to the vertical.

Figure 2.2 plots this relationship for several defect diameters. The steep slopes of the right sides of the curves as S approaches $R - W (1 - 10^{-T/20})$ indicate that guidance changes have a large effect on dropout length or repeatability as S approaches $R - 2.8$ mils.

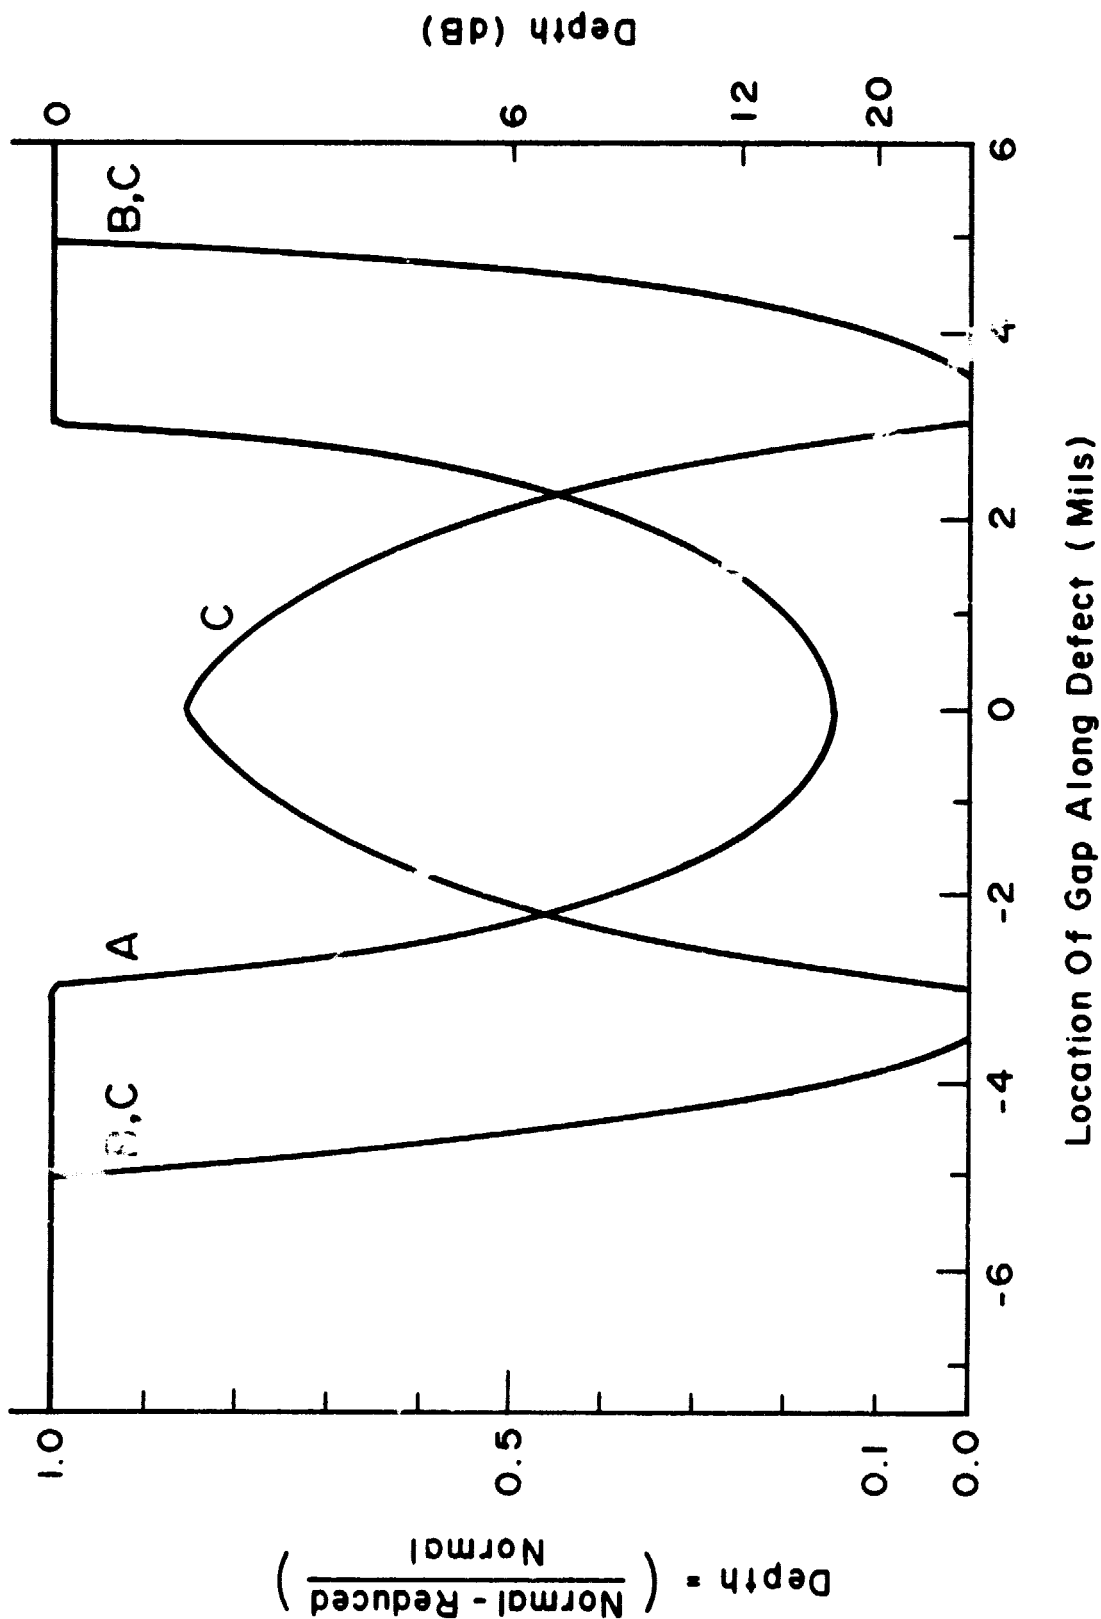
Figure 3.1: Dropout signal profiles calculated for model defects centered over a 7 mil track. Curve A results from a 3 mil defect radius and constitutes a subthreshold profile, Curve B results from a 5 mil defect radius. Curve C assumes a 3 mil radius oxide surface projection with a 5 mil effective defect radius resulting from tenting around the projection. Real defects cause profiles similar to all three of the curves.

Dropout signal profiles or depth profiles are the reproduced signal amplitudes as a function of the gap location relative to the defect. They can be observed with an oscilloscope at the filtered output of a diode dropout detector. Depth profiles can be difficult to interpret when the track center to defect center distance is unknown, but multiple track length measurements enable alignment of the track with the defect prior to profile observations. Figure 3.1 plots dropout signal profiles calculated from three model defects to illustrate likely mechanisms for three commonly observed profiles. Curve A results from a circular defect with an effective radius which is too small to cause a 20 dB signal reduction. The larger defect radius employed to calculate Curve B results in a defect that completely covers the track along most of its length, producing an essentially rectangular profile with total elimination of the signal. Both profiles could result from a circular depression or a surface projection of nonmagnetic material such as a base film asperity or a dust particle. The model defect employed to calculate Curve C is a 3 mil radius cylindrical projection of magnetic material on the oxide surface which might result from a calendering defect or a loose oxide binder particle. An effective radius of head to tape separation equal to 5 mils is assumed around the particle as in Curve B, but partial head to tape contact is resumed as the magnetic defect passes across the head gap, resulting in a bilobed signal profile with two amplitude minima.

Irregular signal profiles result when physical defects vary widely from the circular model. Rough surfaces and closely spaced groups of defects can cause irregular profiles. Groups of closely spaced profiles can be associated with groups of closely spaced defects aligned with the track.

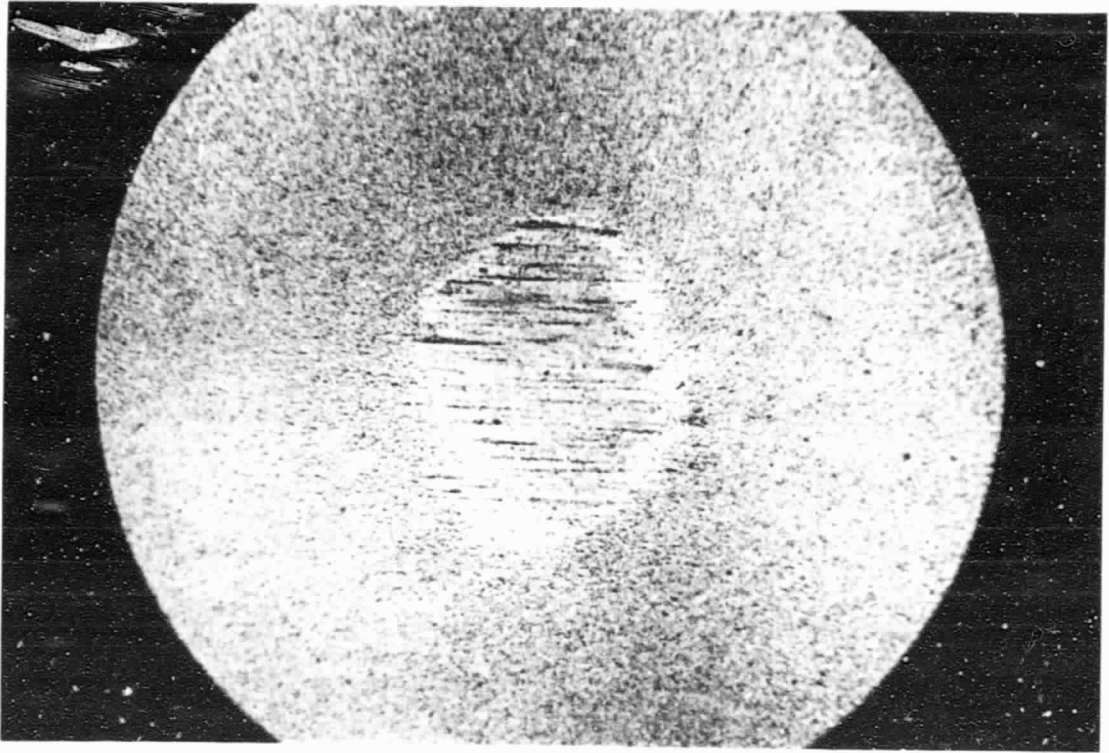
Figure 5.1 - Oxide and defect surface a a typical copy of
the repeating base film asperity on 3M 5198
(400X magnification)

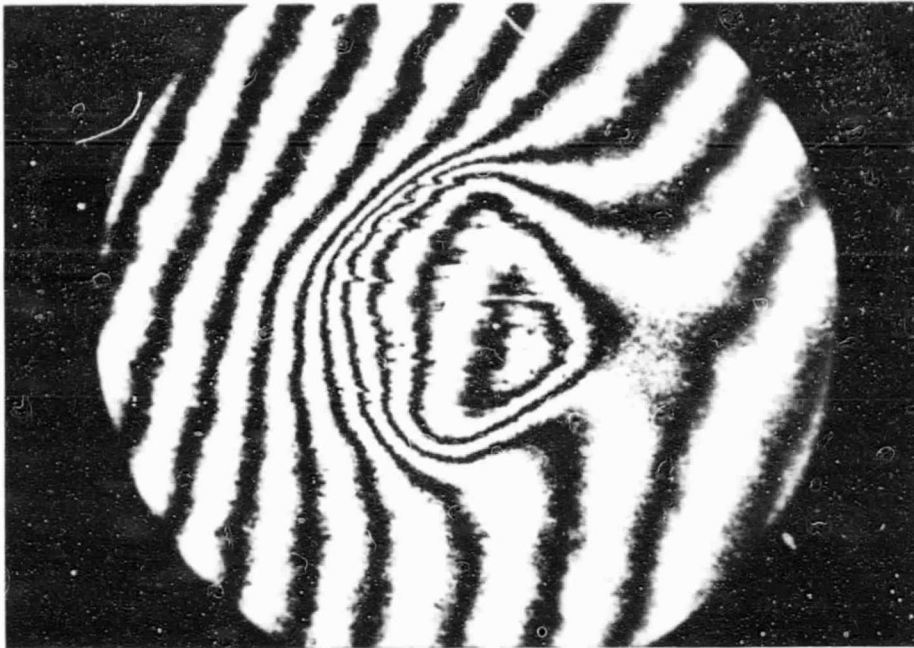
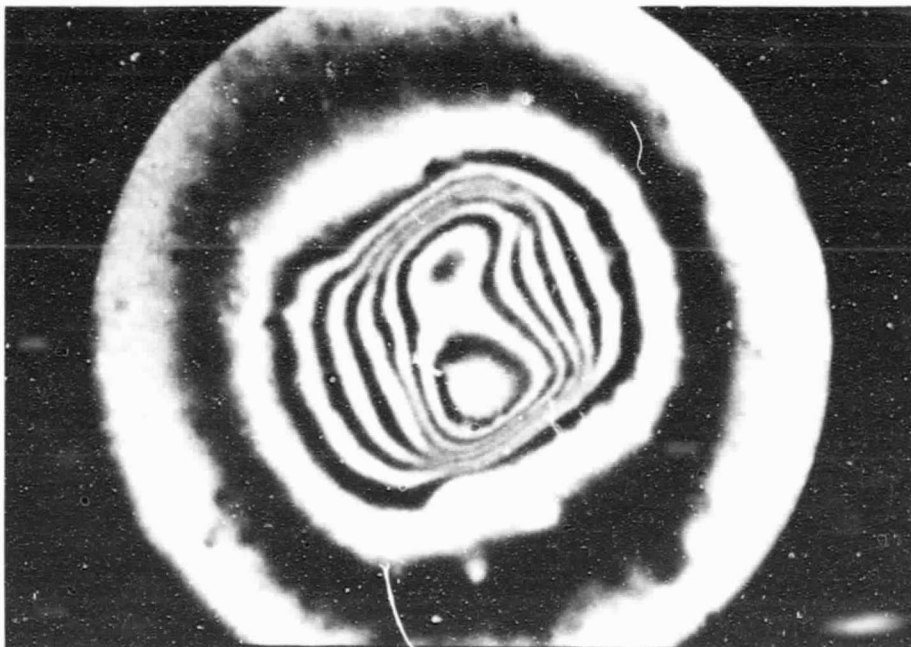
Figure 5.2 - Surface profile at 3M 5198 base film asperity
 a) with oxide binder coating and
 b) after removal of oxide binder coating
 (320X magnification).

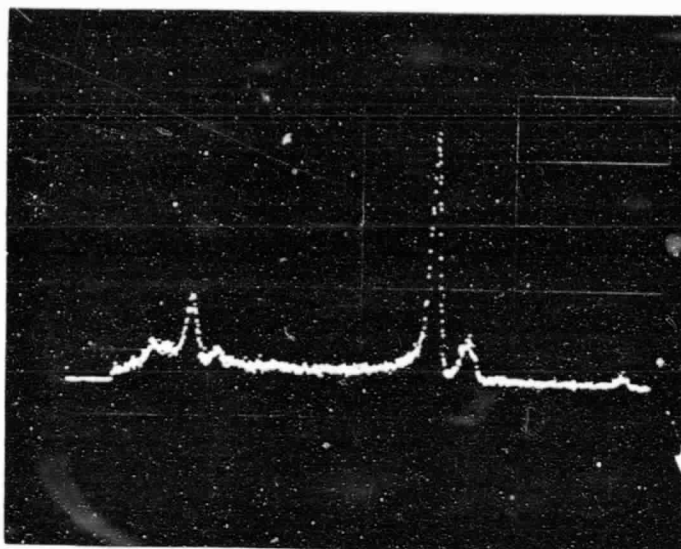
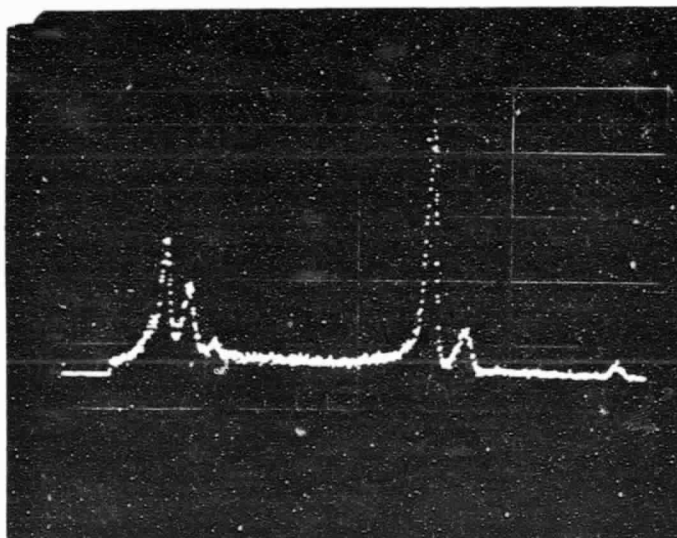
Figure 5.3a is an EDAX spectrum from a normal 3M 5198 oxide binder surface, while Figure 5.3b indicates the effect of a small foreign body inclusion located near defect 3M 5198-35-D. The normal spectrum indicates traces of chlorine and silicon in addition to strong iron peaks, and typical gold and aluminum artifacts. The same elements are detected on both spectra, but the enhanced silicon peak present on the foreign body spectrum suggests a silicon dust particle, while the detection of iron and chlorine can be expected from partial electron beam penetration through the small particle. The size and location of this foreign body was not associated with a 20 dB dropout. These spectra should be compared to other 3M 5198 EDAX results.

Figure 5.3: 3M 5198 EDXRA spectra of
a) normal oxide surface, and
b) small foreign body inclusion
showing enhanced silicon peak.
The silicon inclusion location
and dimensions were not associated
with a dropout.

The EDAX spectrum from this defect is very similar to normal 3M 5198 oxide binder (Figure 5.3a), but the gold peak of the defect spectrum appears slightly enhanced when compared with the primary iron peak. This could result from partial attenuation of the electron beam as it passes through a thin purely organic material to the underlying oxide coating.

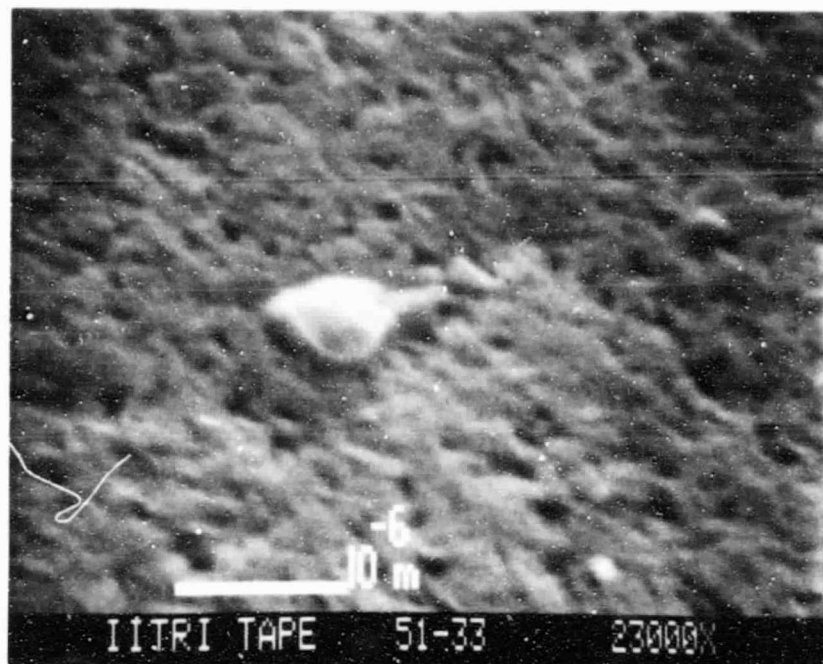
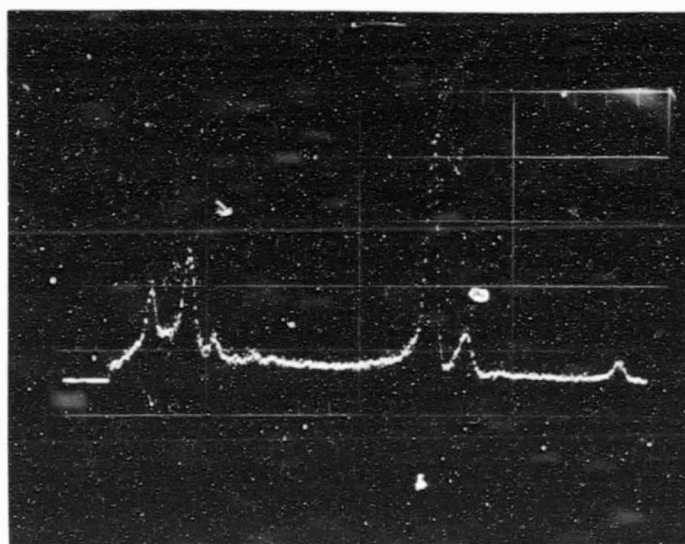
One additional interesting 3M 5198 EDAX was obtained from a submicron surface adherent and/or partially imbedded particle which appeared to project 10-20 microinches from the tape surface. The dropout signals that resulted in the identification of this particle were initially classified as permanent, but they actually occurred on adjacent tracks after the virgin recording and the second recording. The particle of Figure 5.4a was found "accidentally" during examination of a more typical deposit that was probably too small or too worn to cause a permanent dropout. The particle was not observed during the defect optical identification procedure. It produced the EDAX spectrum of Figure 5.4b which is high in aluminum but also contains traces of potassium and tin. Probable burnishing agents include aluminum oxides.

Figure 5.4 - a) SEM and b) EDAX of a small particle located on the surface of 3M5198. This particle was not positively identified as the cause of a dropout.

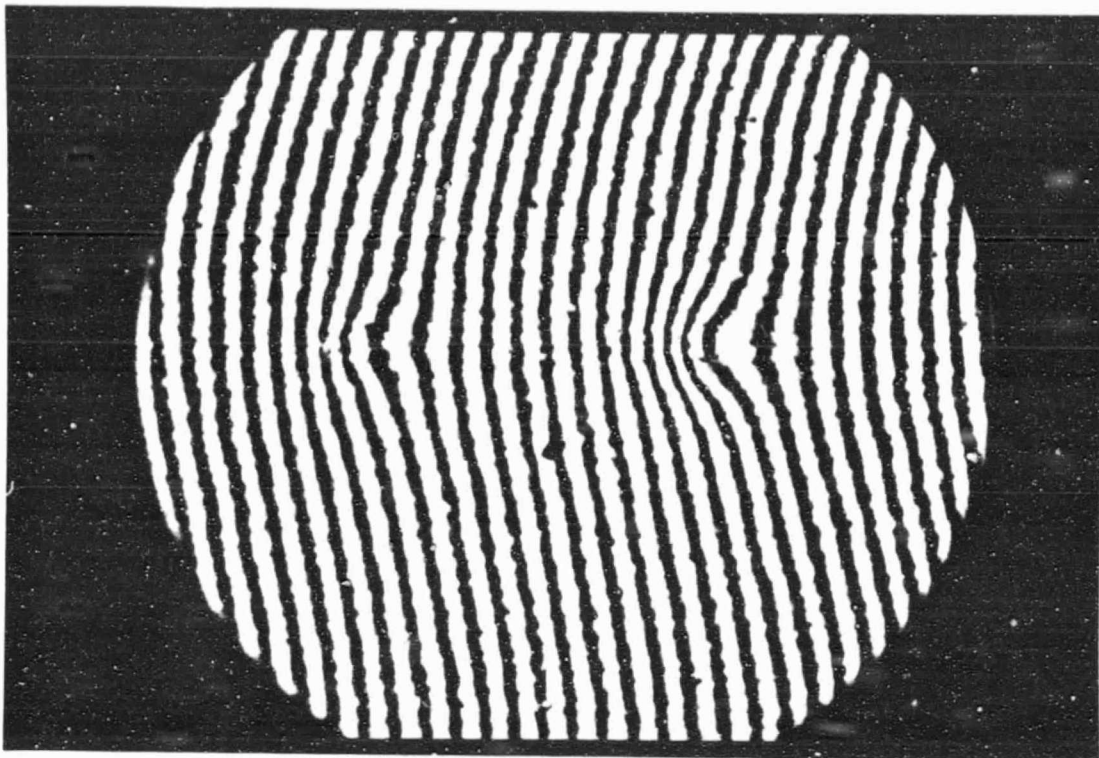
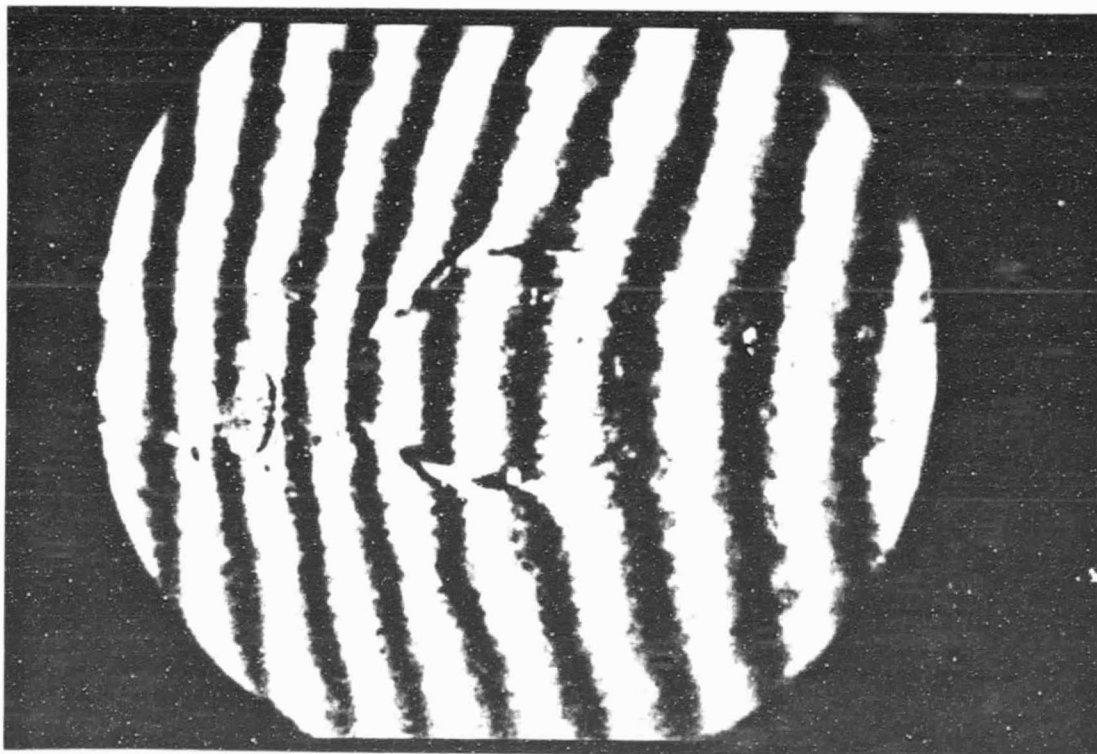
This dropout registered on a single track with a length of 147 wavelengths or 8.8 mils following the virgin recording and 117 wavelengths or 7.0 mils following the second recording. Signal profiles were not observed. A series of similar smooth edged ovoid outlines were observed close to the track center. Smaller irregular masses were present on the take up side of the first and last ovoids in the series, which were separated by 36 mils.

Interference microscopy showed that only the first and last ovoids had significant surface profiles (Figure 5.5a). The profiles do not indicate directly whether the defect projects from the surface or is impressed into the surface, and the profile is too slight to determine its direction from shadowing by oblique lighting. Several features suggest a surface projection. Figure 5.5b shows that the sharp outline of the ovoid with the greatest profile is defined by a narrow ring 3.5 mils wide by 4.5 mils long with a profile in the same direction as the wider overall profile seen at lower magnification. A slight curvature over a large area of the tape surface at the defect was caused by over intense illumination during defect identification and makes the interference band shifts difficult to measure precisely, but the smaller profile is about 5 microinches which may not be sufficient for a 20 dB dropout. The greater profile is estimated at 17 microinches including the 0.4 band interval shift of the narrow ovoid ring. A narrow ring depression would not contribute much to loss of signal, and the width of the defect at the 10 microinch contour is narrower than the track, suggesting tenting by a projection increased the effective width of the defect. The irregular masses observed on the take up side of the two profiles could be material picked up by the heads from elsewhere on the tape and deposited at the projections, but the mass visible on Figure 5.5b may have broken off the ring edge closest to it.

Figure 5.5: Surface profile at defect 3M 5198-40-A. Two prominent profiles are present within 75 mil diameter field of view of (a). Surface curvature away from defects is an artifact. Right feature of (a) is centered in 12.5 mil diameter field of view of (b). Direction of tape travel is horizontal.

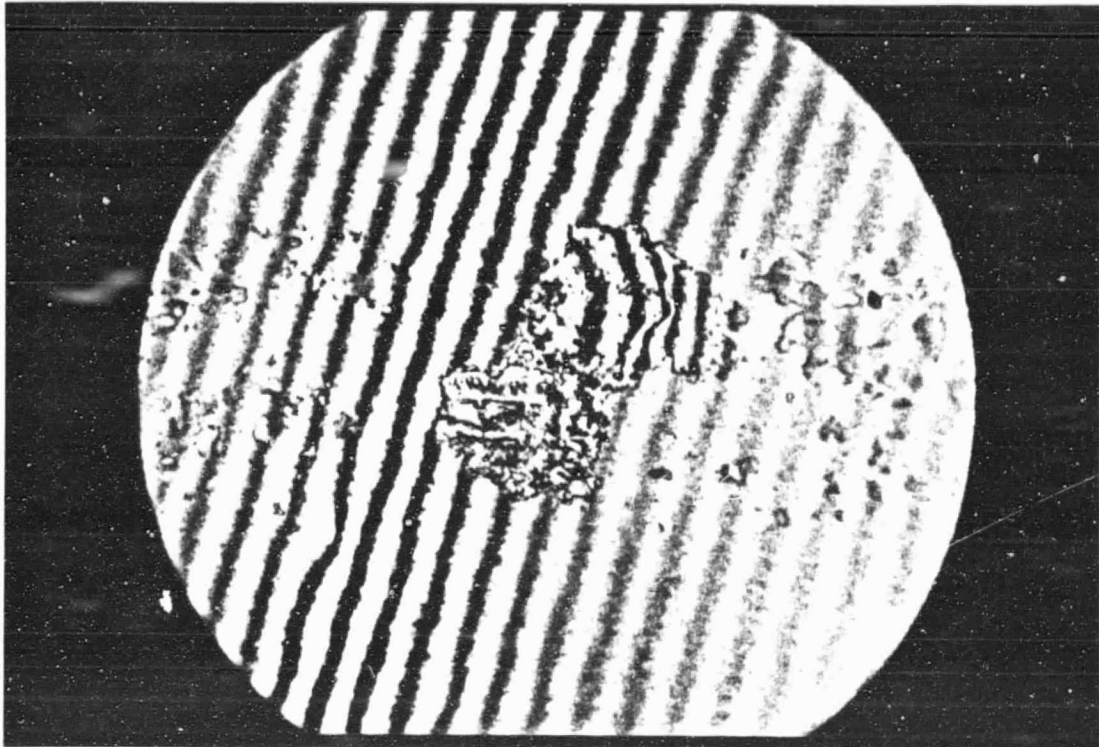
The measured length of this dropout decreased from 4.8 mils after the virgin recording to 3.0 mils after the second recording. A dark feature with maximum dimensions less than one mil was affixed to or partially imbedded in the oxide surface at the dropout location. The dark appearance was due to an irregular shape characteristic of mineral dust that prevented direct interference microscopy of the particle. The likelihood of a small fixed surface projection made this defect a good candidate for measurement of the tenting effect.

Figure 5.6: White light interference micrograph of defect 3M 5198-41-A within a 12.5 mil diameter field of view. The dark band touching the left edge of the defect corresponds to the narrow sharply curved band over the upper right side of the defect, which is shifted more than 4 band intervals. Direction of tape travel is horizontal.

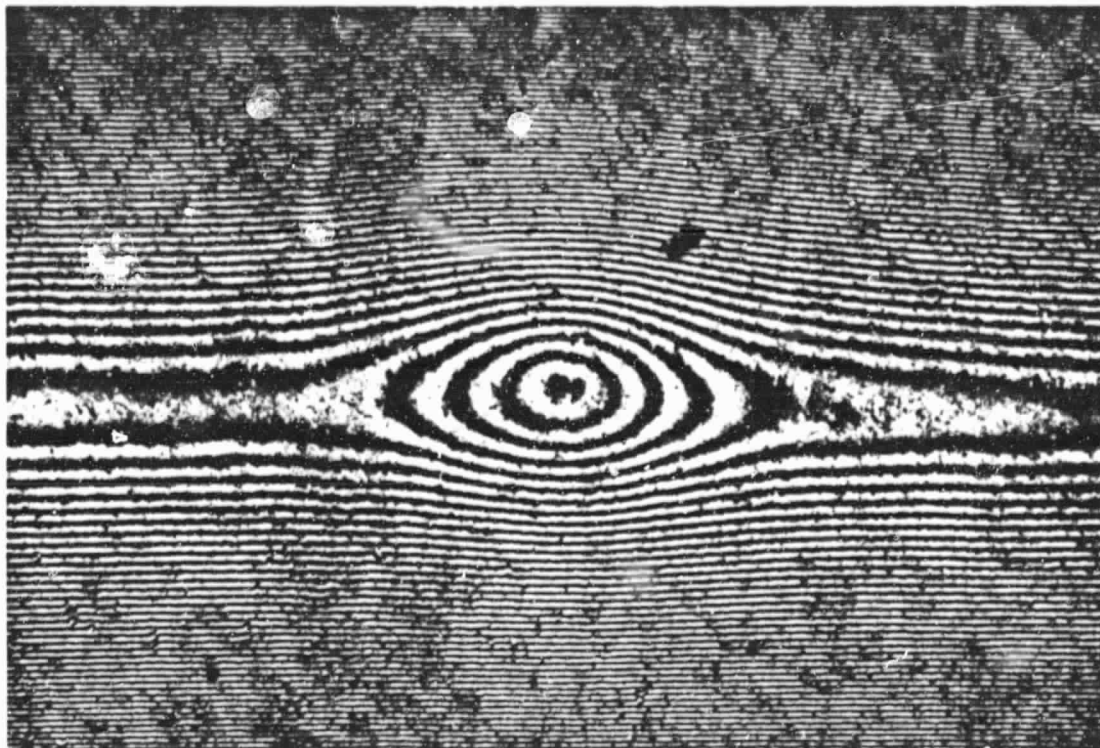
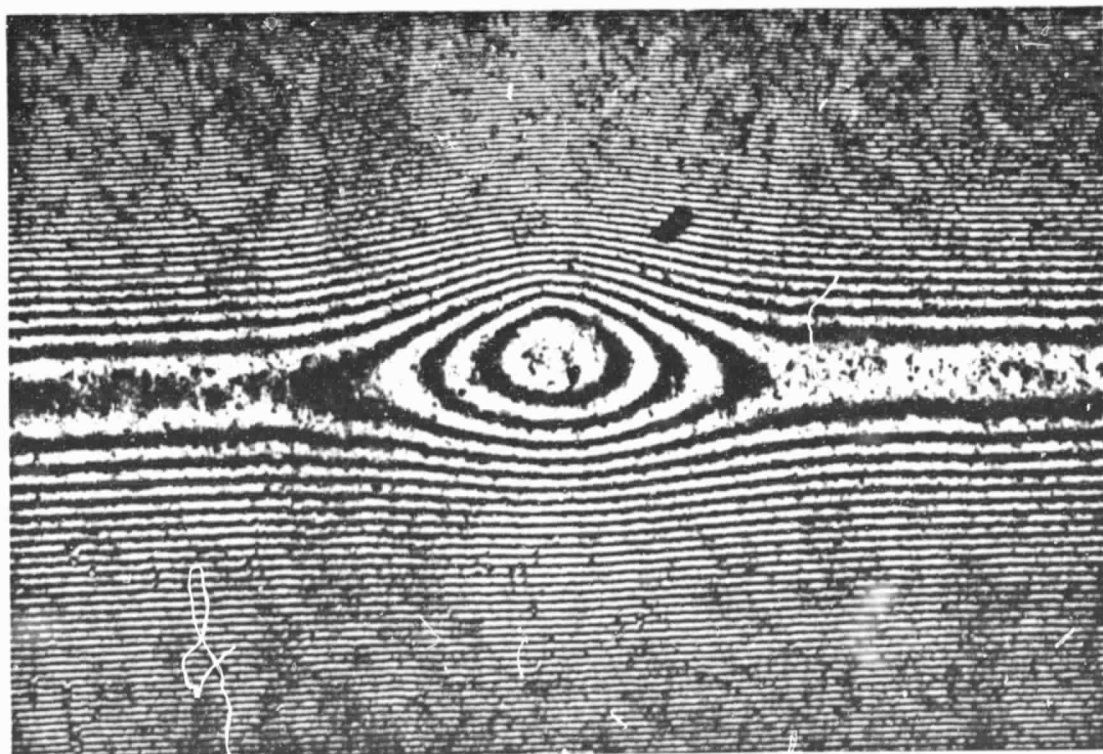
Figures 5.7a and 5.7b are interference micrographs indicating the contours on the back side of the tape with this defect displaced two different distances from the vertex of the glass tubing. The vertex is the widest band and represents the center of the 5.3° wrap or the gap location of the head simulation. For a perfect cylinder, the interference band edges would be straight lines with decreasing separations at greater distances from the vertex until beyond the wrap limit where the separations become constant.

The defect location is the point of maximum deviation of the bands from the horizontal and its displacement from the gap is determined by finding the horizontal line with the greatest number of band crossings and measuring the distance to the vertex at the center of the broadest band. The height of the defect is determined by the number of bands crossed on that horizontal line. Figures 5.7a and 5.7b have defect to gap displacement distances of 3.6 mils and 6.7 mils respectively, with defect heights of 48 microinches and 50 microinches respectively.

Table 5.2 lists measured widths along the gap at four contours caused by tenting at the two defect displacements. Radial distances from the defect to the intersection of the gap and each contour are also listed. Circular contours would produce equal distances for a given line across the table. The measured distances are actually longer for the greater displacement, suggesting elliptical contours, and the distances between contours suggest a gradual change in reproduced signal loss with respect to position along the gap rather than the abrupt effective area assumption of the model. It is likely that the change in record losses would be more abrupt than the slope of the separation distance due to the narrow switching field distributions of oriented particles. It is notable that the dimensions at the 16 microinch contour are much greater than the measured dropout length, while a separation distance of only 10 microinches was estimated for significant combined record/reproduce losses earlier in this report.

Figure 5.7: Tenting effect around defect 3M 5198-50 B. Scale is 9.74 mils/inch. Simulated gap location is along center of widest band, and defect locations (a) 3.6 mils from gap, and (b) 6.7 mils from gap were measured by the technique described in the text.

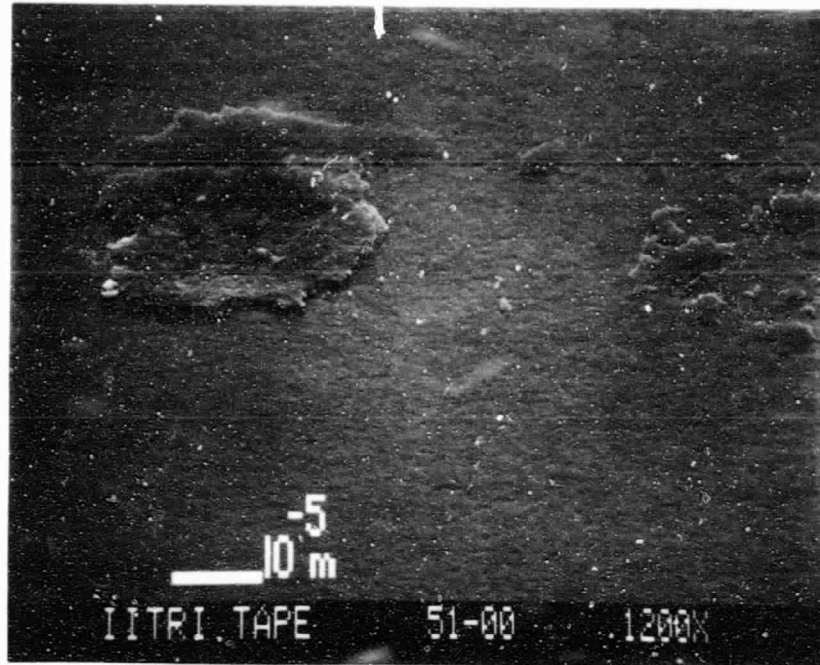
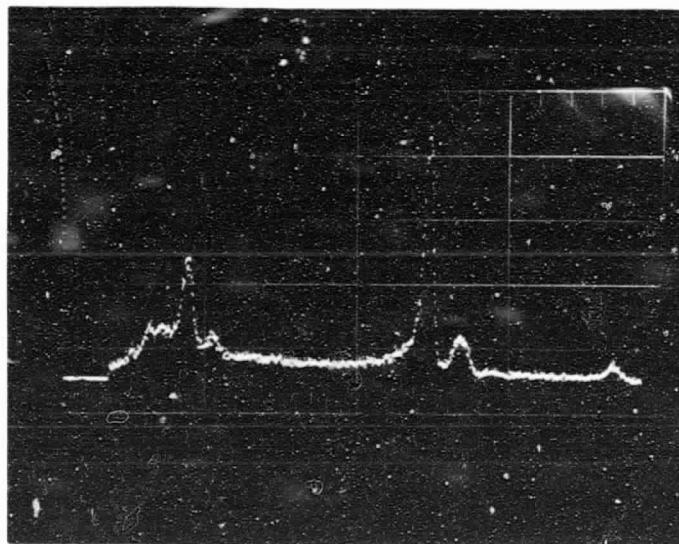
Figure 5.8a is an SEM of the larger particle at this defect, and Figure 5.8b is an EDAX taken over most of the particle area. The lower three-fourths of the particle surface exhibits longitudinal grooves expected for surface wear during passage over the heads, but the smaller deposits and the upper fourth of the main particle have very smooth surfaces. Mechanical contact between practically any solid materials should enable observation of the typical grooved wear surface at this magnification, and the lower profile above the horizontal boundary between the particle areas suggests a reproduce track edge. Thermoplastic deformation (melting) of the particle has been suggested as a cause of the smooth surface. Presumably, heat would be produced by friction between the projecting reproduce head and the tape or defect surface. Note that normal 3M 5198 oxide binder surface including calendar marks never appears worn or deformed after passage of the head.

Figure 5.8 - a) SEM and b) EDAX of Larger
Feature at Defect 3M 5198-00-C

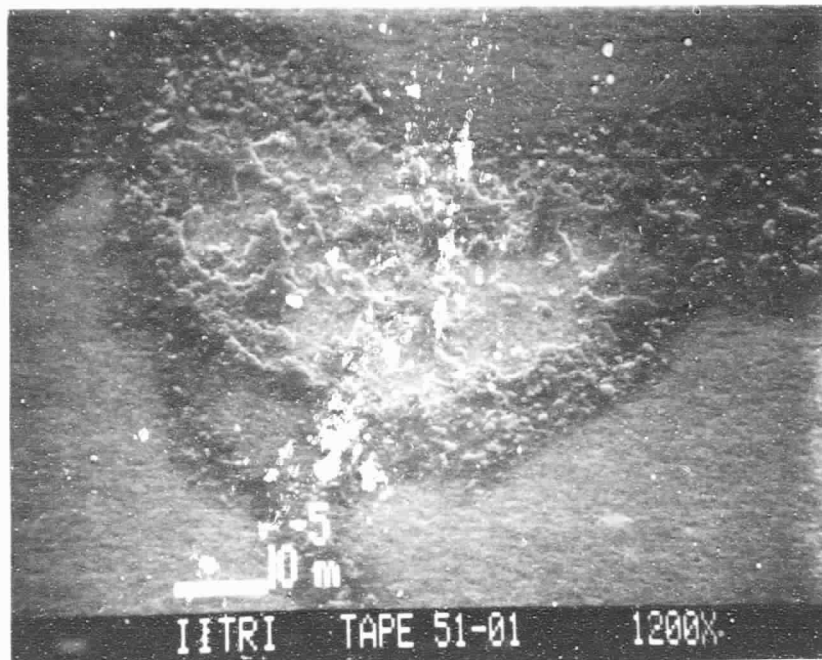
A smooth club shaped outline extended 4 mils across the tape width and 1 mil along the tape length at the dropout location. An irregular outline within the thick end of the club shape and a similar adjacent shape were consistent with removal of an oxide particle from a surface impression and its redeposition immediately after the impression, similar to the SEM appearance of defect 3M 5198-12-C.

Figure 5.9 - Portion of Rough Surface at Defect 5198-01-C

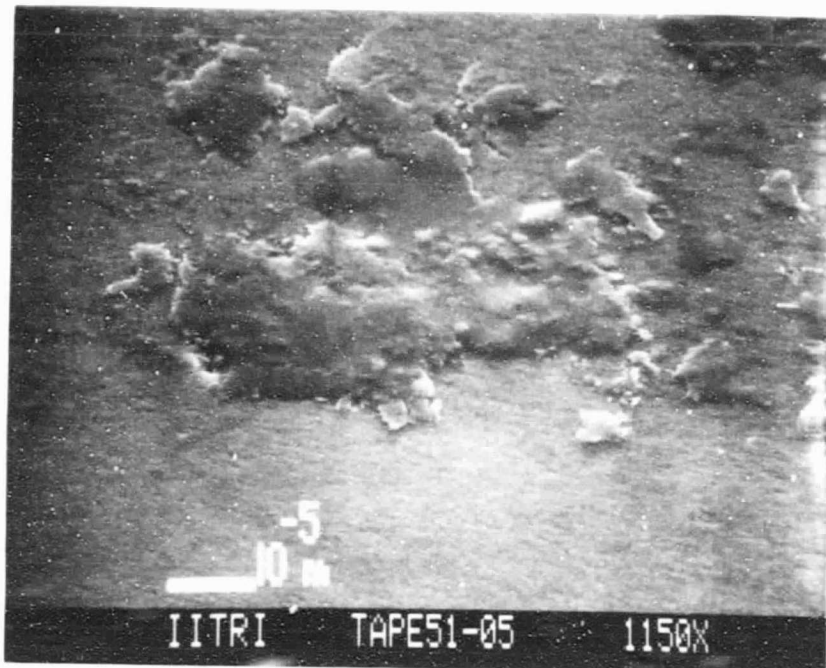
The smooth defect edges disappeared under dark field illumination or SEM, and rough deposits appeared. The varied texture of Figure 5.10 suggests a combination of surface wear and thermoplastic deformation. The EDAX spectrum of this area was like normal oxide binder without an enhanced gold peak.

Figure 5.10 - SEM of Deposit at Defect 3M 5198-05-C

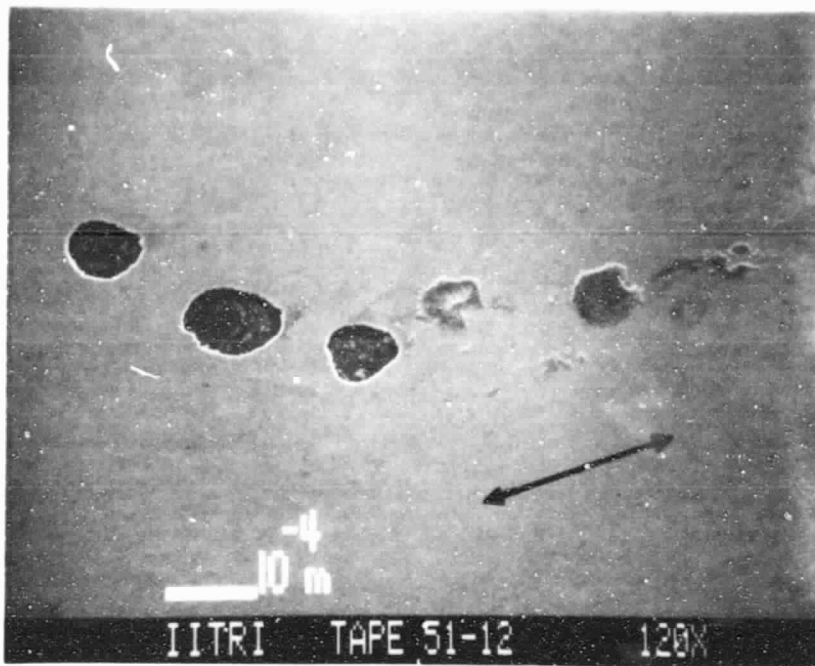
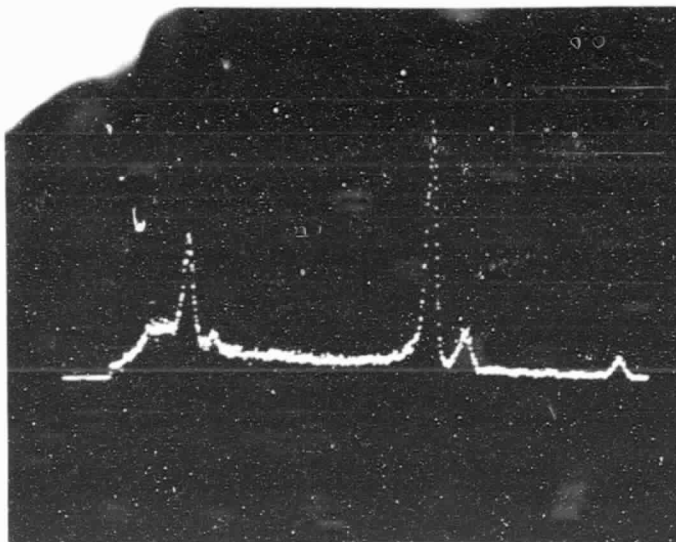
The dropout lengths suggested a large unstable or irregularly shaped defect, and the optically identified defect is consistent with long dropout lengths near the center and guidance sensitive dropout lengths on each end of the defect. A sinuous 50 mil long smooth outline extended diagonally across the tape and enclosed a series of ovoid or irregular features. The ends of the outline were diagonal across the long axis of the tape while the center curved parallel to the long axis. Two ovoids near one end of the ridge had large profiles which were revealed as depressions by shadowing, while the center of the sinuous outline excluding irregular nonreflective shapes had a 15 microinch profile extending upward from the tape surface and therefore constitutes a ridge.

Figure 5.11a is a low power SEM showing that oxide binder has been removed down to the base film at the optically observed depressions, and that the removed oxide binder or other material has been deposited along the tape. The deposits are along the sinuous ridge which does not show clearly in this SEM. Since the individual oxide free areas are less

Figure 5.11 - a) SEM showing three oxide free areas at one end and deposits along center of defect 3M 5198-12-C, and b) EDAX of large deposit closest to oxide free areas. A low profile oxide free ridge encompassing all of the notable features cannot be seen clearly on the SEM, but it extends beyond the field of view on the right side of the image and bears smaller deposits which were aligned with additional dropout tracks. Arrow indicates direction of tape travel.

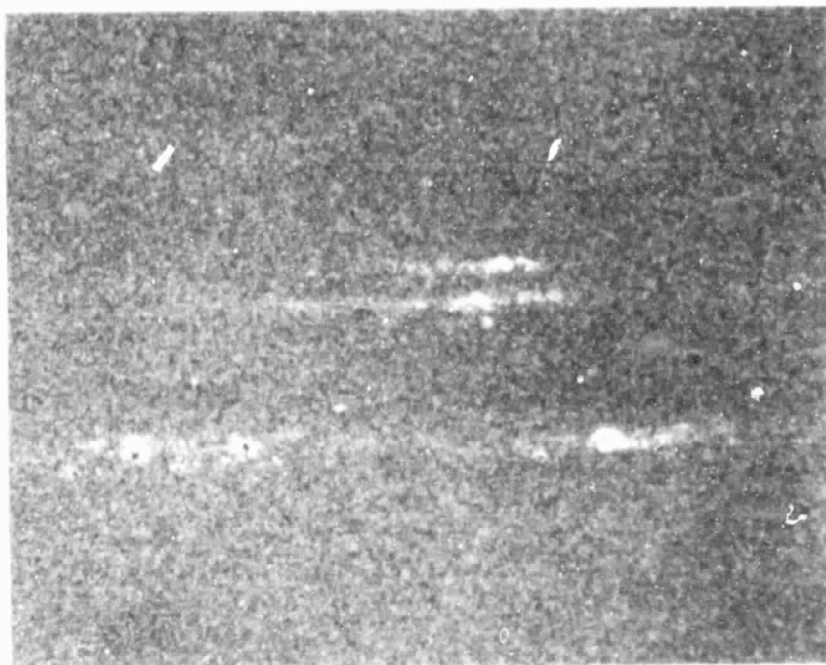
This dropout affected four adjacent tracks after the virgin recording with lengths of 8.6 mils, 14.2 mils, 12.5 mils, and 9.1 mils. It repeated on the center two tracks after the second recording with lengths of 15.7 mils and 19.0 mils. The signal profile observed for the 19 mil length track suggested an overall effective length of 40 mils which agrees well with the 35 mil long by 7 mil wide group of smeared surface material identified at the dropout location. Apparently, wear decreased the physical profile and effective width of this defect while smearing increased its effective length between the first and second recordings.

Figure 5.12 - Dark Field Micrograph of Defect
3M 5198-32-C at 82X Magnification

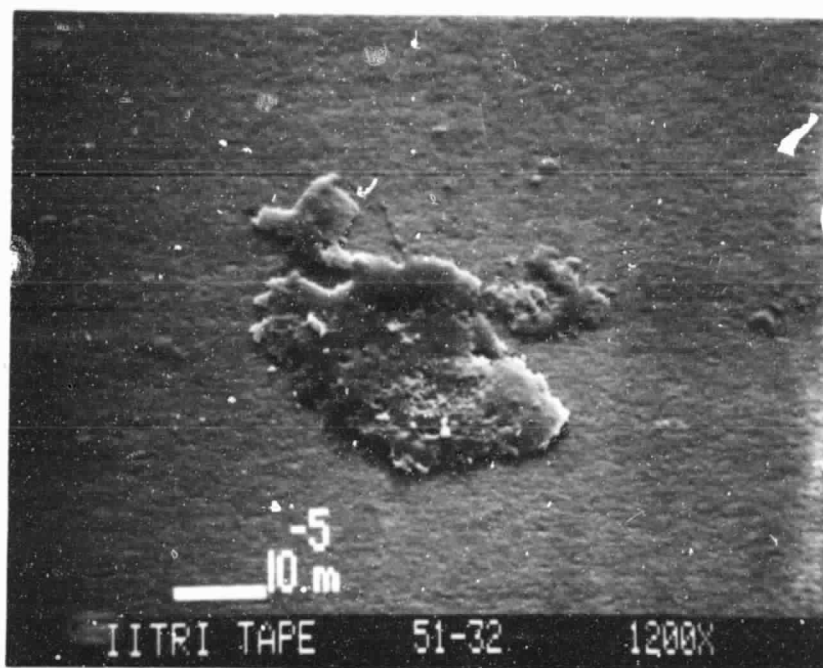
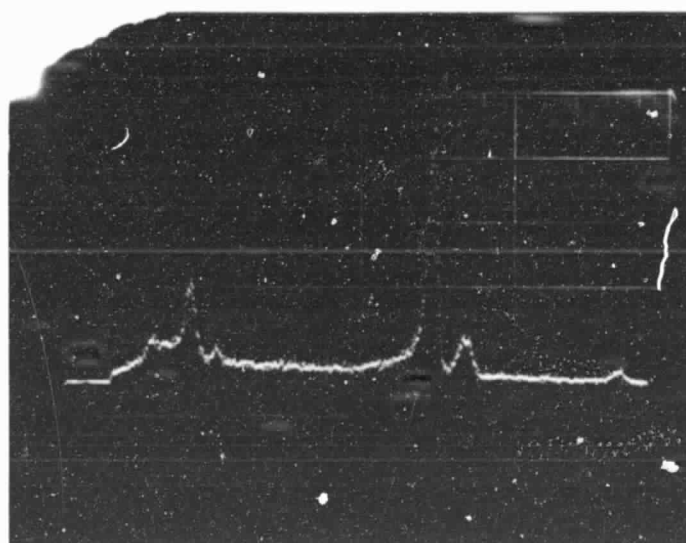
Figure 5.13 - a) SEM and b) EDAX of
One Particle from Defect
3M 5198-32-D

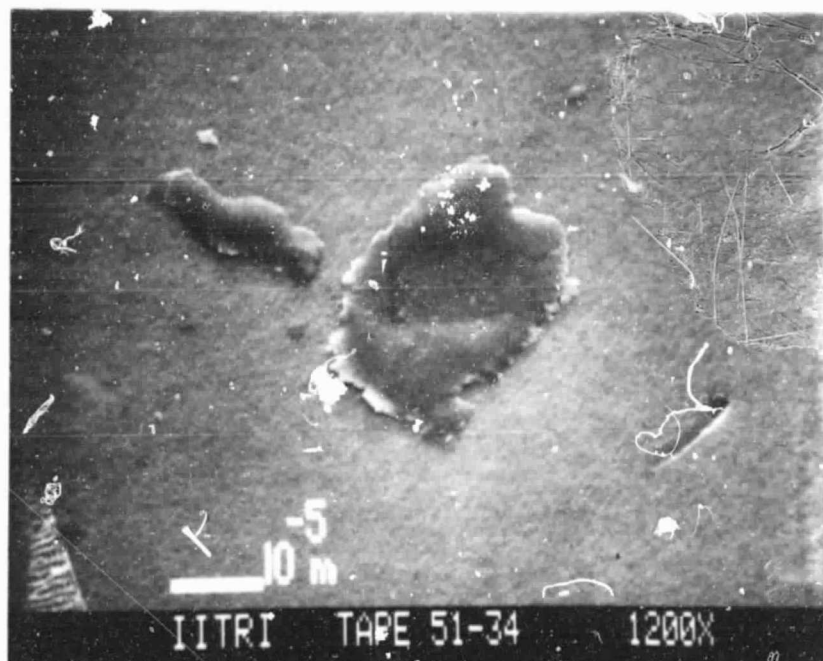
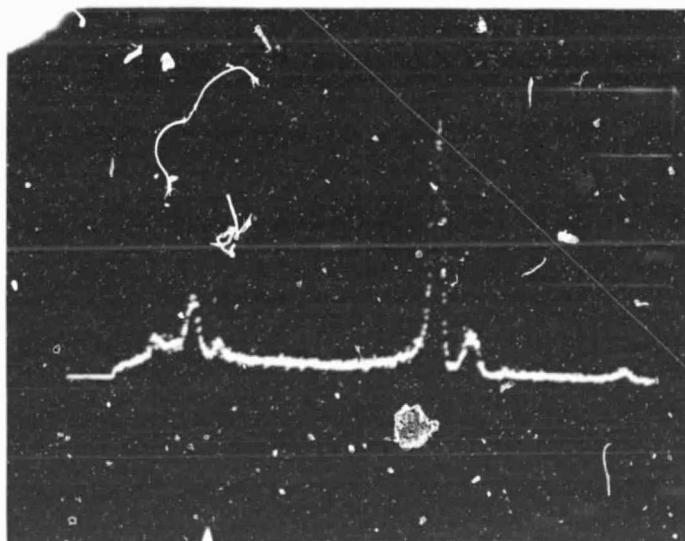
Figure 5.14 - SEM and EDAX of Defect 3M 5198-34-D.
 SEM includes one of the largest particles
 among a group that occurred within a
 35 mil long by 7 mil wide area. EDXRA
 of this particle is consistent with
 oxide binder material.
